Shear Strength of Unreinforced Masonry Walls Retrofitted with CFRP

This paper investigates the in plane behavior of unreinforced masonry (URM) walls externally strengthening on both sides by different configurations of unidirectional carbon fiber reinforced polymer (CFRP) wraps. In order to evaluate the effectiveness of using the strengthening systems to improve the in plane behavior of masonry walls, the experimental program was conducted by testing four specimens. Initially, URM wall without retrofitting system; considered as a reference; was tested. The other specimens were retrofitted on both sides by different configurations of unidirectional CFRP wraps. Walls were tested following diagonal tensile (shear) test method. Then the effect of position, spacing, and reinforcement ratio on ductility, stiffness, shear behavior and failure modes of URM wall were evaluated. Experimental results confirmed the effectiveness of using CFRP in improving energy dissipation, strength, stiffness and ductility of URM wall. Furthermore, the strengthening system affected in a direct way the shear capacity and the deformability of URM walls.

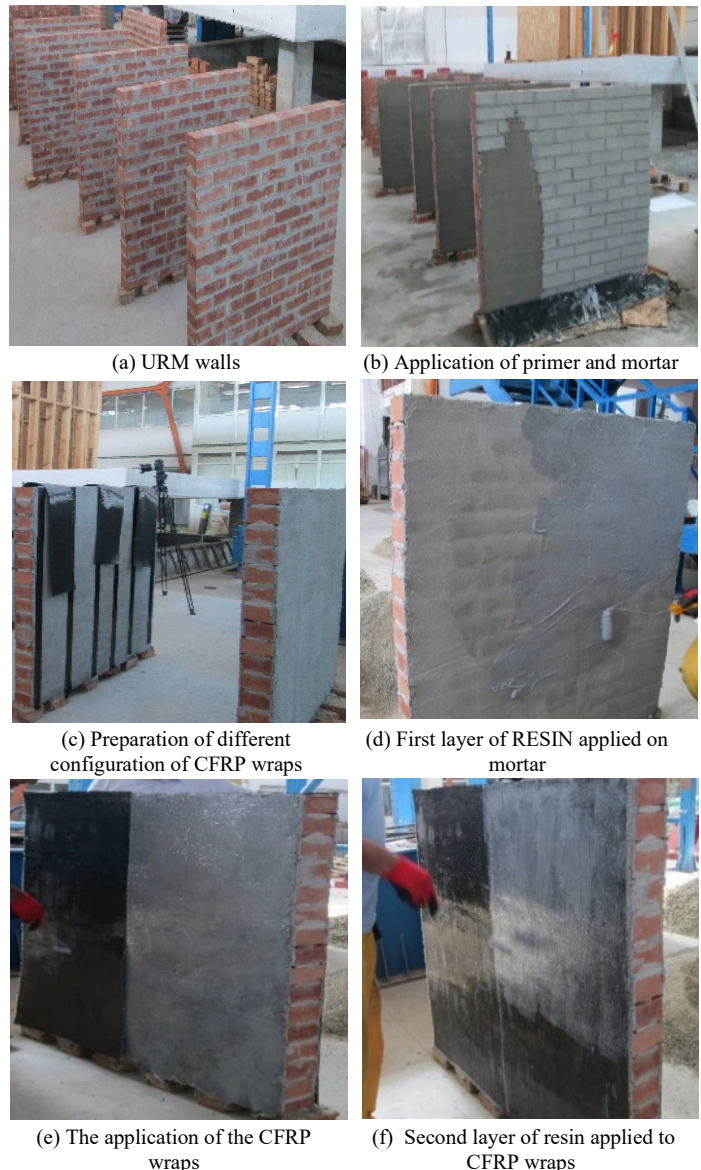
Figure 1: Different steps of retrofitting URM wall by the CFRP wraps

The experimental study passed through several stages; first, URM walls with dimension of 1200*1200*115mm were constructed by qualified masons using clay brick masonry units with dimension of 240*115*63mm, linked by a 10mm joint layer of mortar, then URM walls were cured for 28 days. The procedure of strengthening masonry walls started with surface coatings, which consist of preparing walls by cleaning the both sides of walls and especially the joints from dust with a high pressure of air. Before the application of strengthening materials, walls sides were wetted, and then a thin layer of primer and mortar of a nominal thickness of 12mm were applied to walls surfaces. The

main role of primer and mortar is to provide a leveled surface of URM walls; 28 days after, different configurations of CFRP wraps were applied to wall surface after applying the first epoxy resin layer, then a second layer was used to fix CFRP wrap. Then all the strengthened walls were cured for seven days before being tested (figure 1).

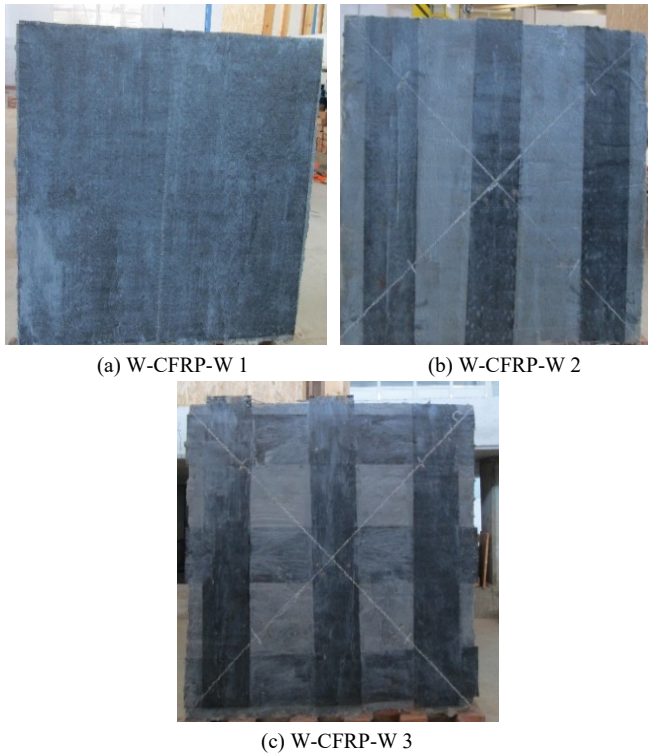
Figure 2: Specimens retrofitted with different configurations

Details of the aforementioned walls strengthened by diverse configurations of CFRP (figure 2) are illustrated in table 3.

Designation	Ratio (%)	Configuration	Dimensions of CFRP (mm)
URM-W-R	-	-	-
W-CFRP-W1	100	Full face	1200*1200
W-CFRP-W2	50	3 Vertical	200*1200
W-CFRP-W3	75	3Verticals & 3 horizontals	6*(200*1200)

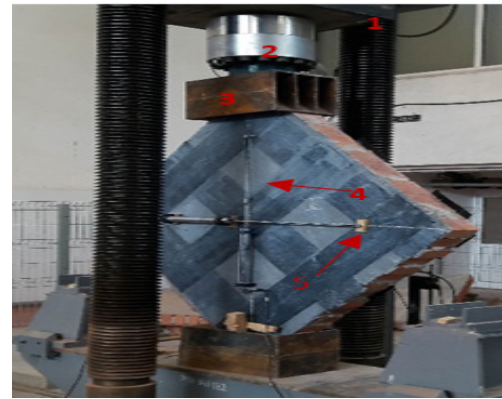
Figure 3: Setup of the diagonal tensile test: (1) Steel frame; (2) Loading plate; (3) Steel shoe; (4) Vertical LVDT; (5) Horizontal LVDT

After the preparation of all specimens, the next step is the determination of diagonal tensile strength of walls reinforced by CFRP. Initially, special attention was given to the specimen transportation from the construction zone to the testing machine by taking into consideration all the security measures in order to keep the same properties and avoiding any deterioration of walls. In accordance with ASTM E519-02[44], the wall was fixed between two steel shoes, which were placed on top and lower corners of the wall to permit the transmission of machine load. Then, four 500mm LVDT's were installed on each side of the wall, to record shortening in the vertical diagonal (compression) and lengthening in the horizontal diagonal directions (traction). Before starting test of each wall, all LVDTs were calibrated. The load applied at the upper point of the wall on the vertical diagonal in the gravity direction through hydraulic jack. The fourth walls

were tested by applying load continuously. Measurement of in-plane displacement of different specimens were recorded automatically through LVDTs by using special data acquisition system. The figure 3 presents the test machine and the emplacement of different equipment.

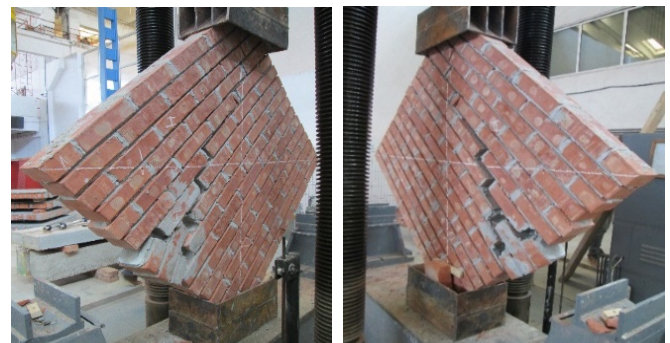
(a) URM side I (b) URM side II

Figure 4: Failure mode of unreinforced masonry wall

The experiment started by testing unreinforced masonry wall. The maximum compression load carried by the specimens was 9.3KN, which correspond to the following vertical and horizontal displacements, for the first side 0.62mm and 0.65mm and for the second side 1.24mm and 0.52mm. When the specimen reaches its load bearing capacity its behavior was characterized by brittle failure started from the top corner of the wall fixed on steel shoes, then the cracks propagated in bed and head joints and diagonal shear cracks were observed which cause a total detachment of an important part of URM wall.

- The first results of URM wall tested under compression loading were characterized by brittle behavior due to the feeble strength of mortar joints when it is compared to the bricks, which occur a shear slip failure accompanied in some case by some cracks in the masonry substrate.

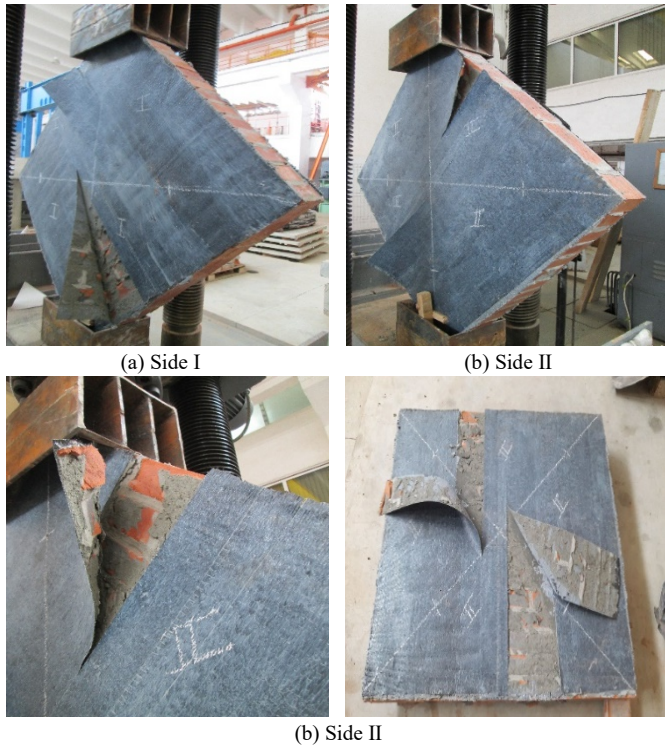
For the first configuration (W-CFRP-W 1), the wall surfaces were entirely retrofitted by CFRP. It was characterized by a symmetrical behavior on its both sides. While increasing compressive loading, diagonal cracks were observed in masonry substrate and shear tensile is transferred via the interface between masonry and CFRP wrap, as a result a partial delamination of CFRP occurred in two opposite directions perpendicular to the vertical diagonal that occur the failure of tested. The CFRP shows their effectiveness in holding the masonry wall that react in this case as one element, consequently an important resistance of the tested wall to in-plane strength was observed. In addition, load-bearing capacity of both sides increased (figure 5).

Figure 5: Failure mode of W- CFRP-W 1

For the second wall, both sides were entirely reinforced by unidirectional CFRP wrap, the peak compressive diagonal load supported by this specimen was 32.3KN, which associated to the following vertical and horizontal displacement, for the first side, 1.2mm and 0.18mm for the second side 4.83mm and 0.37mm. In this case, the reinforced wall had an important strength in compression and in tension; furthermore the behavior of this specimen was characterized by a high ductility and an increase in energy dissipation. Then when the wall reached its maximum load bearing capacity, its strength decrease and cracks initiated from the top and propagated until reaching the bottom of the wall along

the loading direction, then the unidirectional CFRP wrap partially delaminate in opposite directions consequently the compressive strength decreased.

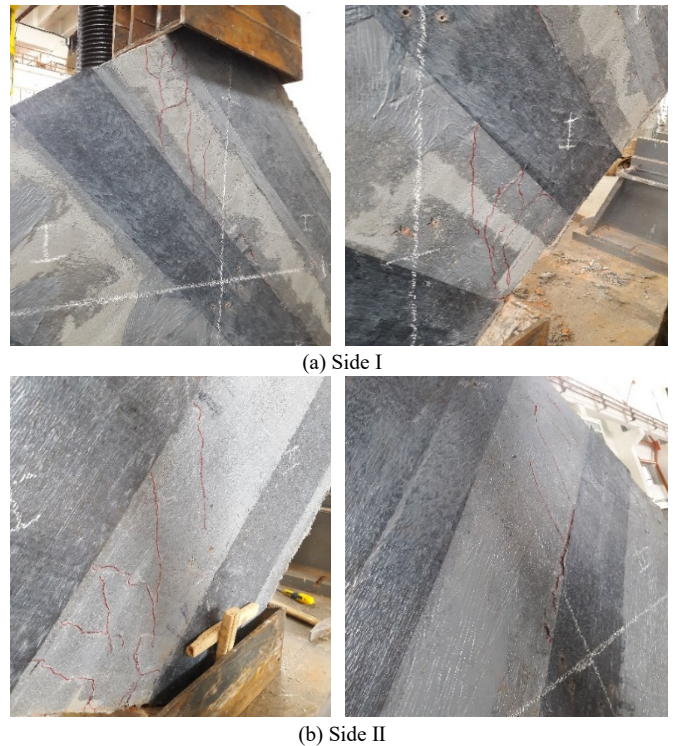
For the second configuration (W-CFRP-W 2), both sides of wall were reinforced by three vertical unidirectional CFRP wraps with a width of 200mm. While increasing diagonal compression loading, the strength of wall increase too, then cracks on both sides of the wall started in masonry between each two vertical CFRP wrap, at the upper and lower corners parallel to the direction of the applied load. The cracks propagation continue in a diagonal direction until they reach the middle vertical reinforcement, which started to delaminate partially from the upper line of reinforcement until it will measure for Side I, 40 cm and for side II, 30cm. Despite the fact that bricks have many cracks, but the reinforced wall, remains stable. Furthermore, no collapse produced while transporting tested wall. Delaminating were located and observed at the end of cracked masonry that transferred tensile load via interface masonry-CFRP wrap (figure 6).

Figure 6: Diagonal shear cracking and delamination of CFRP wraps

The third tested Wall, was reinforced on each side by three vertical symmetrical layers of unidirectional CFRP wrap, its failure occurred by successive diagonal cracks parallel to load direction and across the bed and head joints. The cracks appeared between the two parallel layers on the top corner of the wall, and then it propagated until reaching the bottom of the wall and appeared between the other parallel layers. Some cracks appeared in the layer situated in the middle of the wall, which start to delaminate from its mid-height. The specimen reaches 29.4KN corresponding to the vertical and horizontal displacement, for side one 1.03mm and 0.15mm and for the second side 1.9mm and 1mm, which present an increase of more than 3 times in peak load capacity when it's compared to the URM wall.

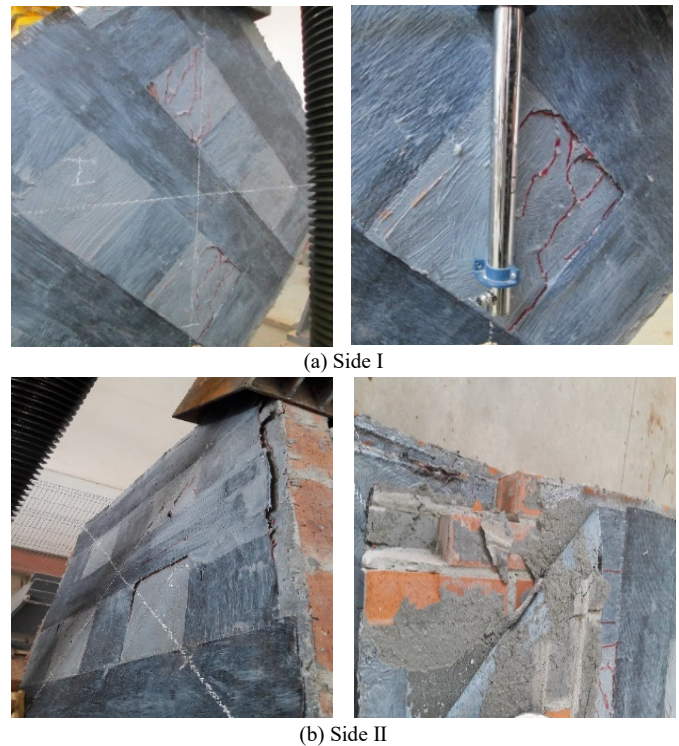
For the third configuration (W-CFRP-W 3), failure mode in the strengthened wall started by subsequent diagonal cracks in masonry and in CFRP wrap, parallel to compression load direction, which was followed by the delamination and rupture of

CFRP wrap in two extremities of the wall. Moreover, a diagonal slippage of some layers situated on the top corner of the wall, which contain just one and a half brick forming a stepped appearance and causing the failure of the walls (figure 7).

Figure 7: Diagonal shear cracking along the diagonal and delamination of CFRP wraps of the strengthened wall

The last specimen is characterized by less load bearing capacity, equal to 26.2KN corresponding to the vertical and horizontal displacement, for the first side 1.02mm and 0.7mm and for the second side, 1.46mm and 3.02mm. In this case, the failure mechanism, diagonal shear cracking initiated along the mortar joints and bricks on the direction of the applied load followed by the delamination of unidirectional CFRP wrap, and then a detachment of the top corner of wall accompanied by a high decrease in strength were observed.
